# Manhole Inspection Summary

Manhole # S35MM\_062MH

Insp Date: **3/8/07 11:17 AM**

**Location** Address: **2011 BARCLAY ST**

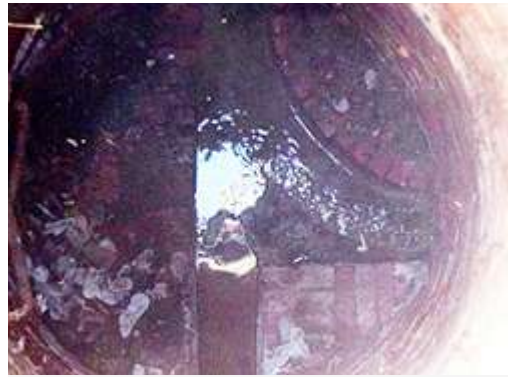
Top View

Corroded and missing steps. Bench and Channel debris.

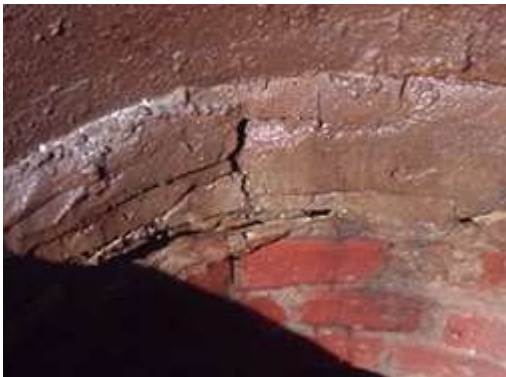
Defect

Frame leaks. Adjustment infiltration.

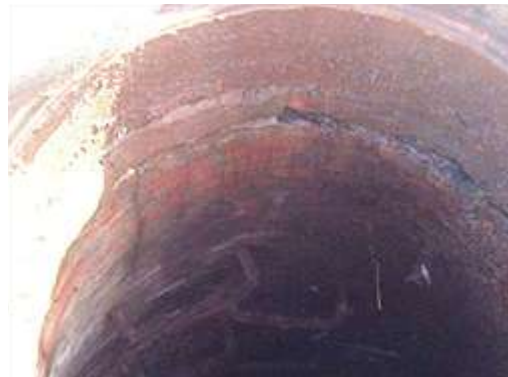
Defect

Frame leaks. Adjustment deterioration and infiltration. Corbel infiltration.

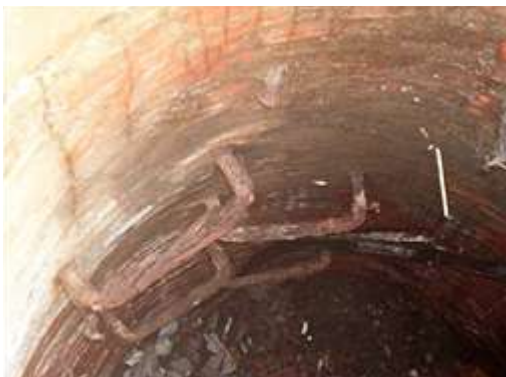
Defect

Adjustment, Corbel and Barrel infiltration.

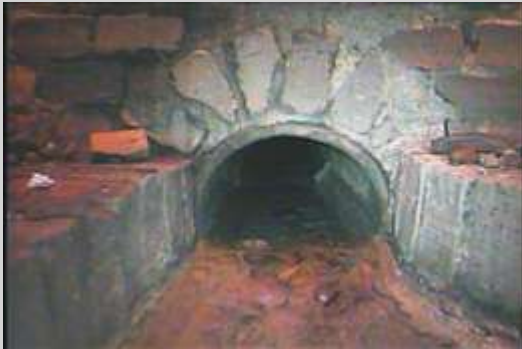
### 8 in. Circular Gravity Sewer Pipe Out @ 12 O'Clock

Deposits: ☒ None ☐ **Mud** ☐ Sludge ☐ **Debris** ☐ Grease

Infiltration: **Evidence** Pipe Seal Cond: **Unknown**

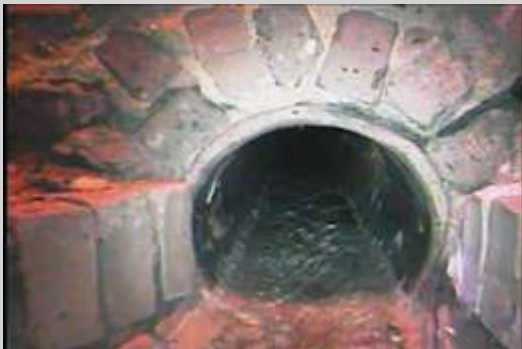
### 8 in. Circular Gravity Sewer Pipe In @ 3 O'Clock

Deposits: ☐ None ☐ **Mud** ☐ Sludge ☐ **Debris** ☒ **Grease**

Silt Depth: **0** (in.) Deposits Extent: **Light**

Infiltration: **Evidence** Pipe Seal Cond: **Unknown**

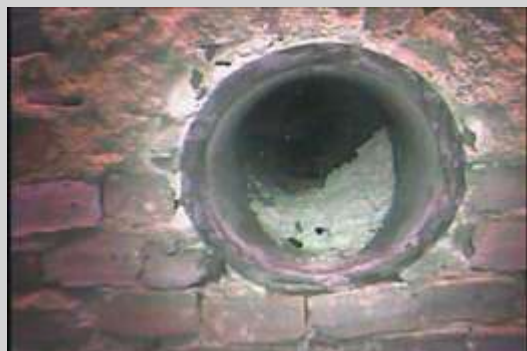
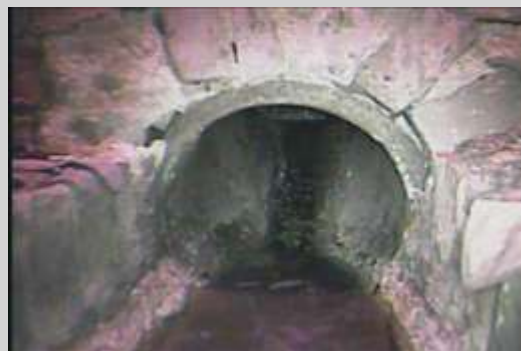
Pipe In @ 6 O'Clock

Deposits: ☐ None ☒ **Mud** ☐ Sludge ☒ **Debris** ☐ Grease

Silt Depth: **1** (in.) Deposits Extent: **Light**

Infiltration: **Evidence** Pipe Seal Cond: **Cracked**
